## **BUILDING MATERIALS LIFETIME NEAR THE COAST**

**Abstract-** This research work is focused on the lifetime of building construction materials, near the coast. This is a historic building located near the coast. The defining characteristic of this building's renovation is its focus on longevity, boasting a lifespan exceeding 93 years. Situated in close proximity to the Adriatic Sea, it stands just 150 meters away from the shoreline. The analysis has been centered around two important approaches. One approach involved obtaining diverse samples of main construction materials like concrete, steel bars, and masonry bricks. The other approach involved non-destructive testing (NDT), specifically using a sclerometer, to derive stability parameters for the various elements. These analyses offer valuable insights into both the operational effectiveness of the facility and the resilience of the construction materials. It's clear that the longevity and performance of these materials will also depend on the ongoing maintenance efforts carried out through the facility's users over the years.

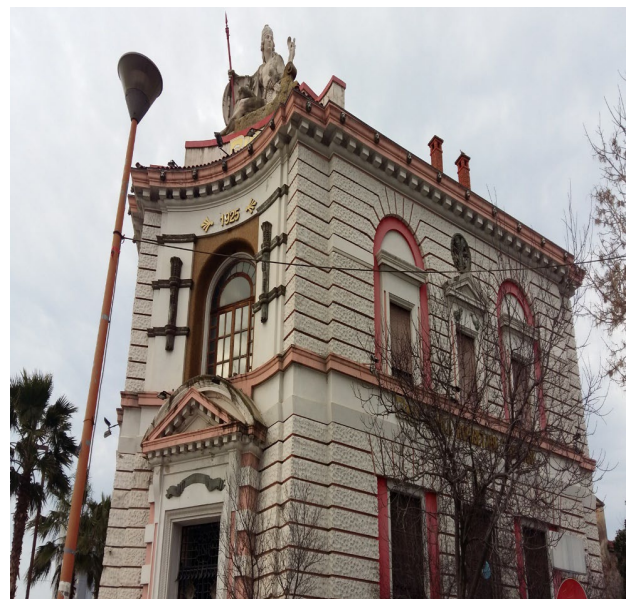
In its entirety, the technical team exercised meticulous caution to uphold the sustainability of the facility, with particular emphasis on preserving the facade, renowned for its profound historical, social, and cultural significance. To this end, all testing procedures were conducted within the interior of the building, ensuring minimal impact on its outward appearance. Following this, surveys were extended to include the exterior facade, necessitating the removal of exterior coatings for thorough assessment. Figure 1 below illustrates a section of the eastern facade prior to the commencement of reconstruction efforts.

Figure 1. National Bank facade building, located in Durres city

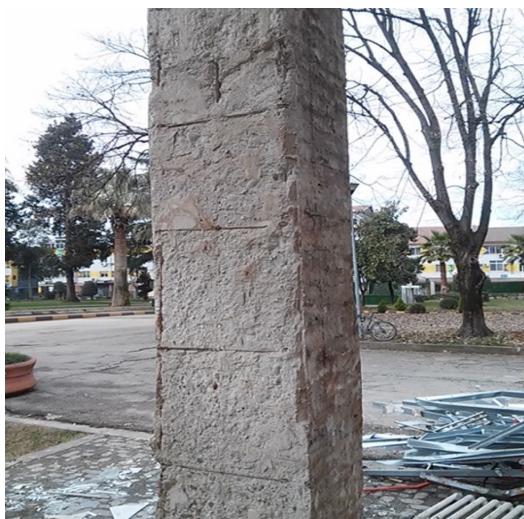
The entire building features retaining walls, with an additional feature of six columns on the basement floor adorned with tiles. The tiles have been removed from columns through the reconstruction process. Upon inspection process, it becomes apparent that the columns do not adhere to all standard specifications, as no concrete protective layer is observed. Consequently, the steel bar within the columns is exposed to the environmental conditions, leading to noticeable the corrosion signs and consequent reduction in the structure's lifespan, as depicted in Figure 4.

Figure 4. Column on the ground floor displaying visible indications of iron bar corrosion

According to the findings, the vertical elements of the concrete floor exhibit a consistent level of compression resistance and composition. Upon visual inspection of samples extracted from within the columns, it is evident that the concrete displays strong cohesion, relatively minimal porosity, and a well-dispersed aggregate grains distribution throughout its structure. In areas where the concrete protective layer has been compromised the steel bars have undergone significant corrosion-induced damage, leading to a reduction in their effective diameter.

Additional reinforcement measures will be implemented as necessary to address these damages. Should reinforcement of the current structure be required, thorough cleaning of the structure, especially of fragile removable components, is crucial beforehand. All vertical support structures must undergo plastering to assess the need for further reinforcement measures. Prior to applying resin with b/a, the exposed surface of steel bars should be meticulously cleaned of rust to ensure optimal bonding between existing steel bars and concrete and new concrete. The design engineer will conduct a comprehensive evaluation of concrete and masonry compressive strength results and provide detailed guidance on reinforcing existing structures, if deemed necessary [20-23].

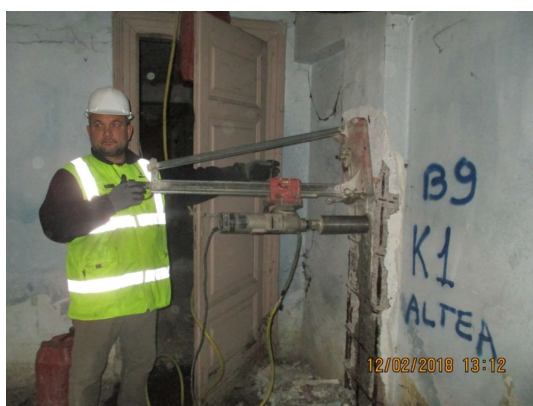
Following the extraction of concrete column samples from the ground floor, the sample results are outlined in Table 2 [9, 11]. From the various tests conducted within the building, three columns were chosen, and samples were prepared. These included two columns such as K1/1 and K1/2 at B9 axis where one comes from K2 at A9 axis. Cylindrical samples have been prepared where ratio of 1:1 correspond to height and diameter, adhering to [17].

Figure 6. The procedure for extracting a sample from column K1 situated along Axis B9

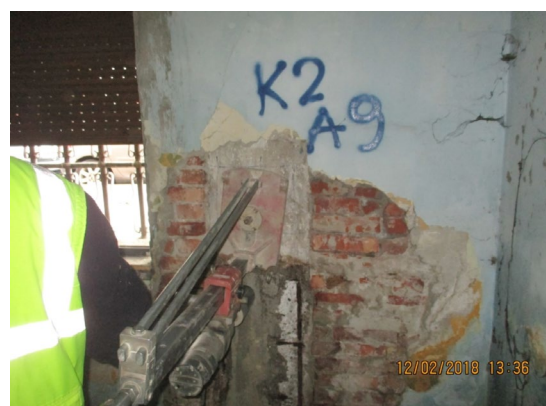
Figure 7. The sampling process at K2 column on Axis A9

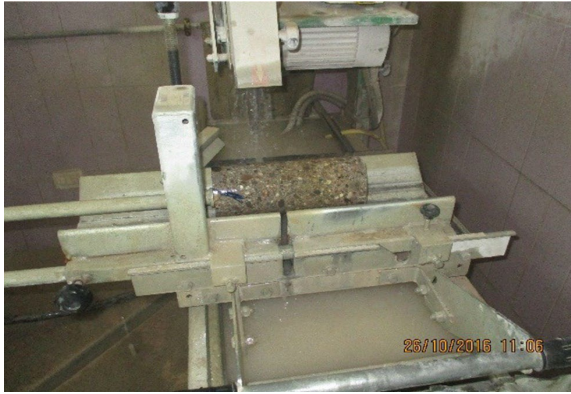
Figure 8. Cutting device for concrete sample preparation

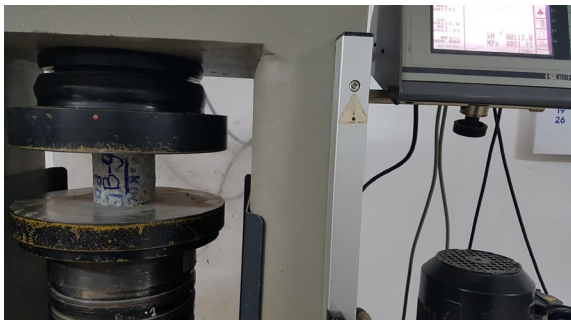
| Location Ground floor | Sample | Height (mm) | Diameter (mm) | Surface (mm <sup>2</sup> ) | Weight (g) | Volumetric weight (g/cm <sup>3</sup> ) | Load (kN) | Compression Strength (N/mm <sup>2</sup> ) |
|---|---|---|---|---|---|---|---|---|
| column; B9 Axis | K1/1 | 78.90 | 81.50 | 6430 | 948 | 2.341 | 144.7 | 22.51 |

Figure 9. Concrete compressive strength, K1 at B9

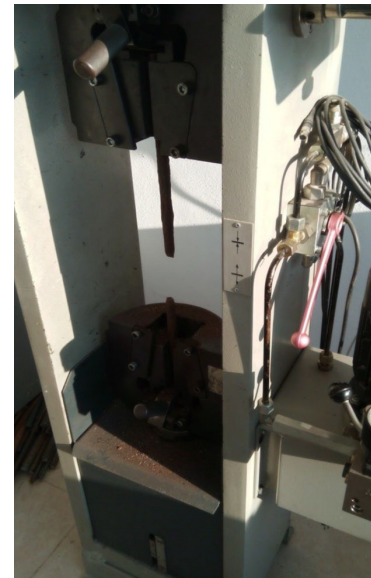
During this study we selected column K1 at the B9 axis in the basement floor and afterward the sample has been tested for mechanical resistance analysis (Figures 10 and 11) [11]. Table 3 depict the test results of the tensile strength analysis.

Figure 10. Tensile test of the steel bar sample

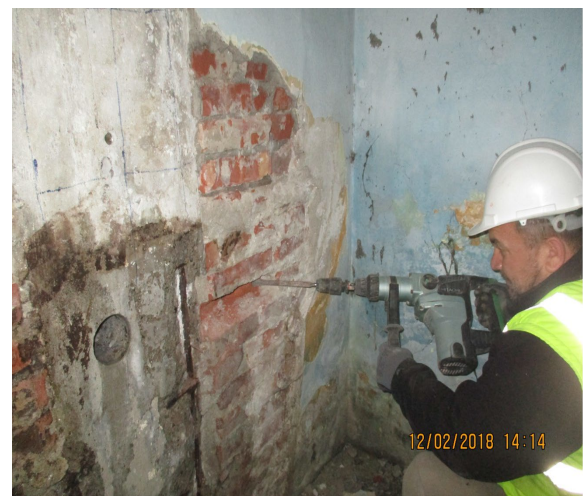
In this study we also have assessed the physical and mechanical characteristics of the masonry components, a specimen has been extracted, comprising a complete red brick bonded with mortar (Figure 11). Subsequently, a masonry specimen was meticulously fashioned, then uniformly sliced and subjected to a compression resistance examination within a laboratory setting (Figure 12). The structure's walls are constructed entirely from such full bricks, each measuring 250×12.5×6 mm in size [19].

Figure 11. Masonry sample taken from wall, A9

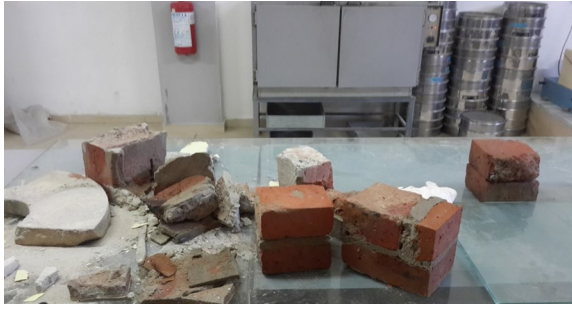
Figure 12. Masonry samples preparation

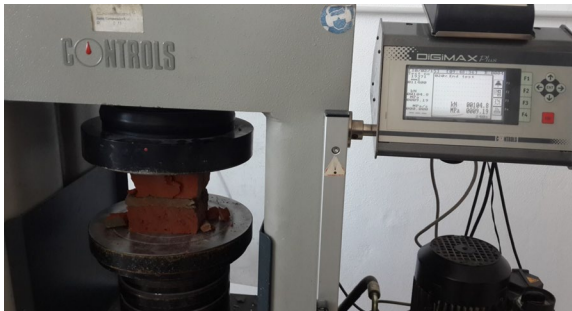
Figure 13 depict laboratory testing of the mechanical resistance of the masonry samples that correspond to the value  $9.29 \text{ N/mm}^2$ .

Figure 13. Masonry compressive strength test
